## **06/08/95 ValuJet Airlines**

## Official Accident Report Index Page

UNCONTAINED ENGINE FAILURE/FIRE VALUJET  
AIRLINES FLIGHT 597 DOUGLAS DC-9-32, N908VJ  
ATLANTA, GEORGIA JUNE 8, 1995

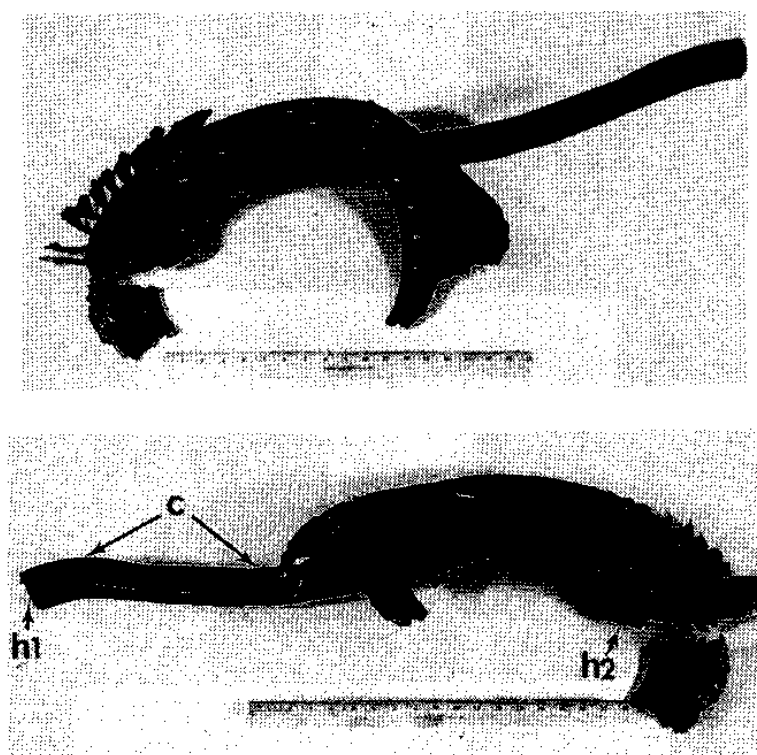
The larger piece of the recovered disk was fractured circumferentially (see arrows "c," [figure 4](#)), which is typical of overstress. About ¼ of the disk outward (toward the rim) of the bore was separated and not recovered. There was a radial fracture of the disk bore at the position shown by arrows "h1" and "h2" in [figure 4](#). Examination of these fractures showed that they were matching overstress separations and therefore accounted for the complete separation of the bore section of the disk.

**Figure 4—Overall views of 7th stage compressor disk as received**

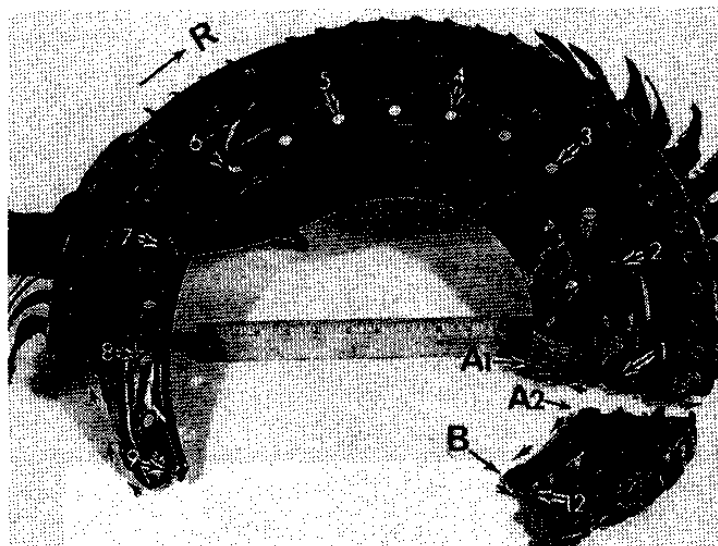
[Figure 5](#) shows the aft face of the two recovered pieces situated relative to each other by fracture matching. The SR holes are shown by arrows "1" through "9" and arrow "12" in [figure 5](#). The SR hole numbering was arbitrarily begun at the radial fracture plane indicated by arrows "A1" and "A2" in [figure 5](#) and progressed sequentially counterclockwise looking forward around the disk (as shown in [figure 5](#)). The missing section of web would have contained SR holes "10" and "11" in the above numbering sequence, and three tierod holes.

**Figure 5—View looking forward showing bulk of the 7th stage compressor disk**

Fatigue cracking was also evident radiating outboard from other SR holes, indicated by arrows "4," "6," "8," "9," and "12" in [figure 5](#). The largest of these fatigue cracks was 5 mm (0.20 inch) outboard from its respective hole. Most of the secondary cracks appeared to initiate at well-defined corrosion pits in the hole wall with the largest and deepest pit measuring 0.01-inch wide at the hole wall and being about 0.003-inch deep. Magnified examination of the cross section of the crack disclosed a surface deposit on the pit cavity wall and hole wall surfaces indicative of the nickel-cadmium plating.

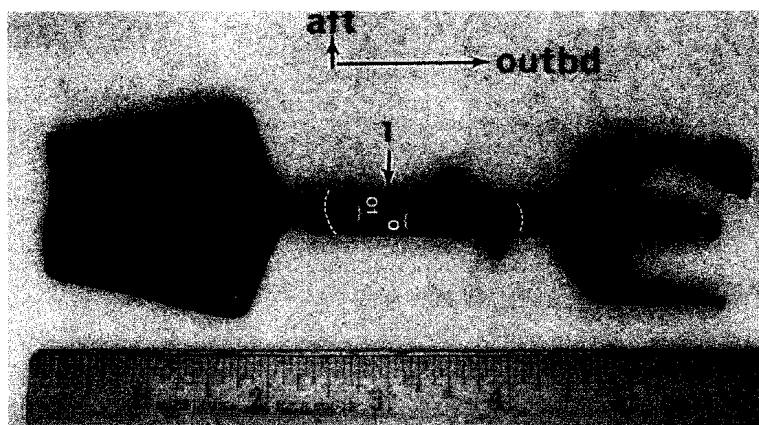
Scanning electron microscope (SEM) examination established that fatigue cracking originated from numerous pits in the hole wall and progressed radially inboard (toward the center of the disk) from SR hole "1," approximately 6.9 millimeters (mm) (0.27 inch). SEM examination also showed evidence of fatigue cracking outboard (toward the rim) from SR hole "1" that measured 22.25 mm (0.88 inch). [Figure 6](#) shows the fracture surface containing the primary fatigue crack.

**Figure 6—Fracture surface containing the primary fatigue cracking**

Visual and SEM examinations of the outboard fracture surface from SR hole "1" showed extensive post-fracture smearing that obliterated most of the microscopic fracture features on the fracture surface. However, some undamaged fracture areas were found that indicated an origin area at the outboard wall of SR hole "1." Features outside of the smeared region up to a distance of about 3 mm (0.12 inch) showed a granular appearance with no evidence of striation development. At this point, fatigue striation development was noted that continued outboard approximately 22.25 mm (0.88 inch) from SR hole "1."

The 0.88-inch fatigue crack outboard from SR hole "1" was the longest fatigue region at any of the SR holes. The crack lengths from each side of the hole combined with the diameter of the SR hole (0.410 inch) gave a calculated overall crack length of 1.56 inch for SR hole "1" at the time of disk separation.
